Surveys of Abandoned Vessels:

Guam and CNMI

**SURVEYS OF ABANDONED VESSELS:
GUAM AND THE COMMONWEALTH OF THE NORTHERN MARIANA ISLANDS**

October 2003

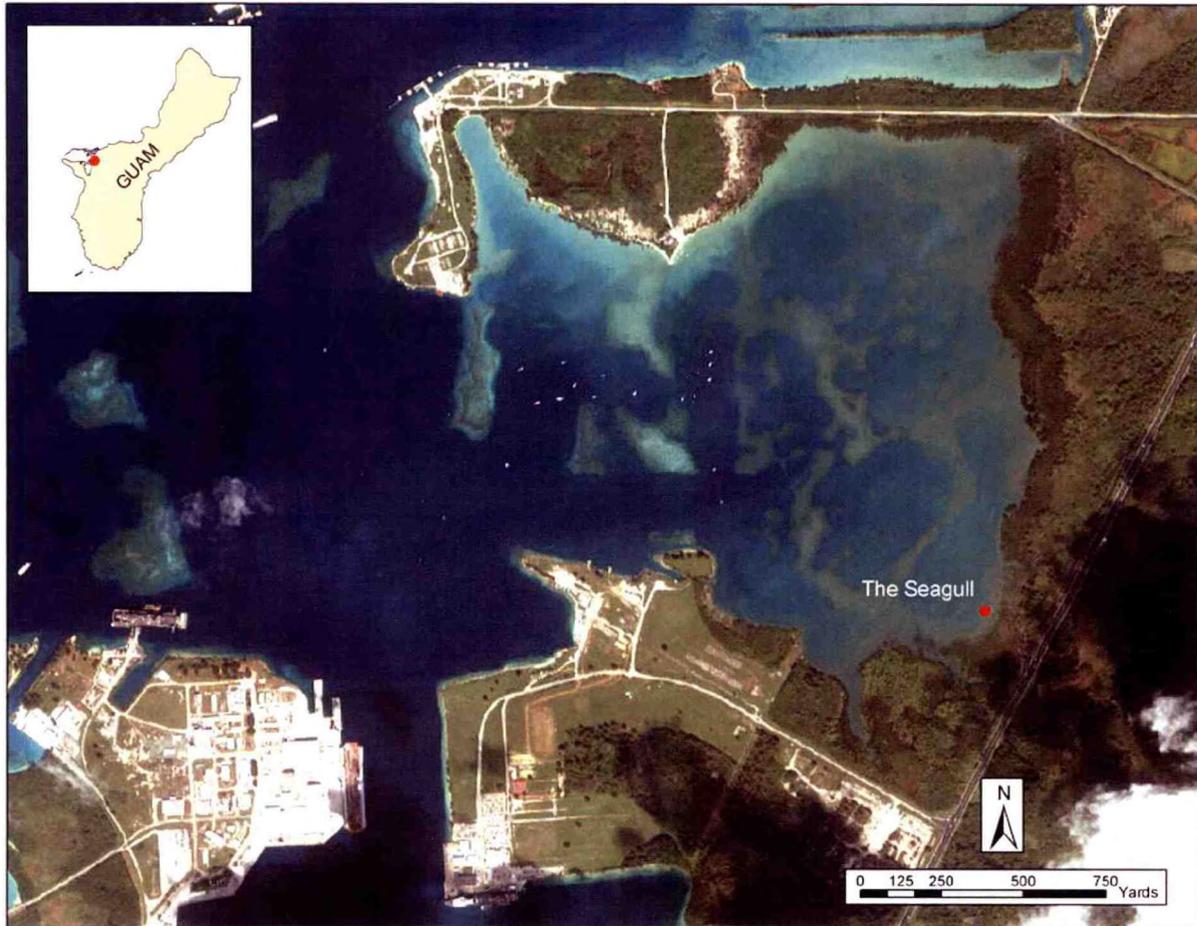
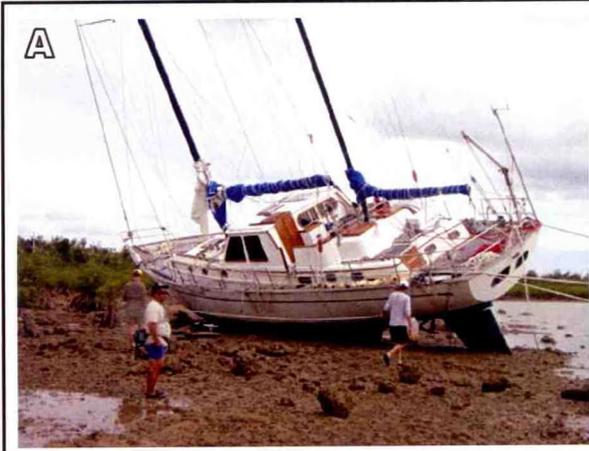
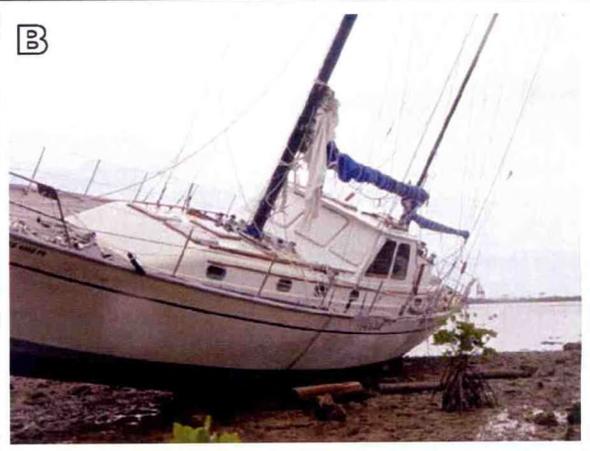
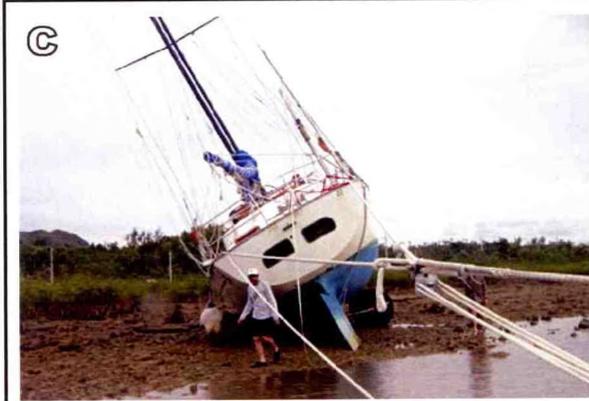
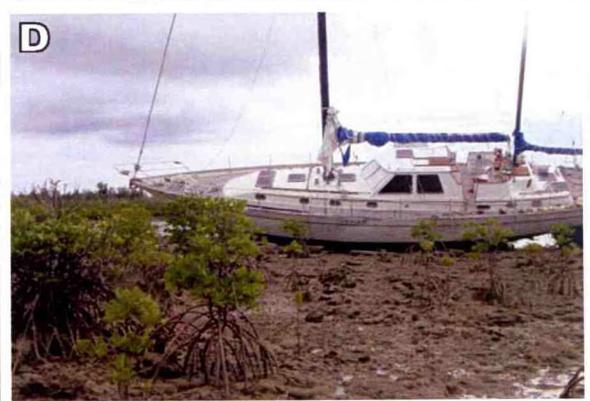
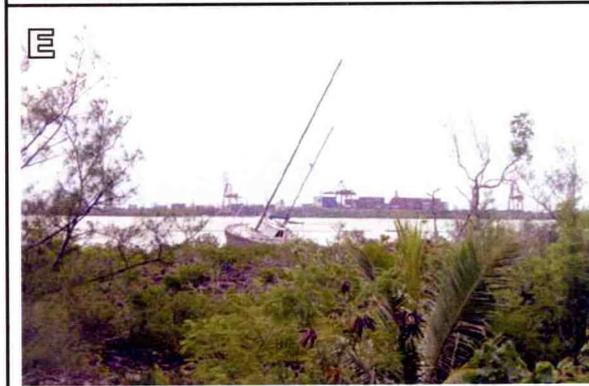
PLATE 1. *The Seagull*, Sasa Bay, Guam.

Vessel Information: The *Seagull* (Incident ID: 2537) is a 70 ft recreational fiberglass sailboat that has been hard ashore since the 2002 Supertyphoon Pongsona. The vessel is in fair condition though the keel is damaged. Large mooring lines, gear, coolers, etc. remain onboard as does 128 gallons of fuel. The vessel is jointly owned by five Japanese citizens, and a local salvage firm is currently applying for removal permits.

- A. View of vessel hard aground on mud-draped cobble and pebble tidal flat.
- B. View of vessel condition.
- C. View of stern.
- D. View of vessel aground in mangrove and tidal flat habitats.
- E. View of vessel from point of access at road.

Removal Scenario: High priority for removal.

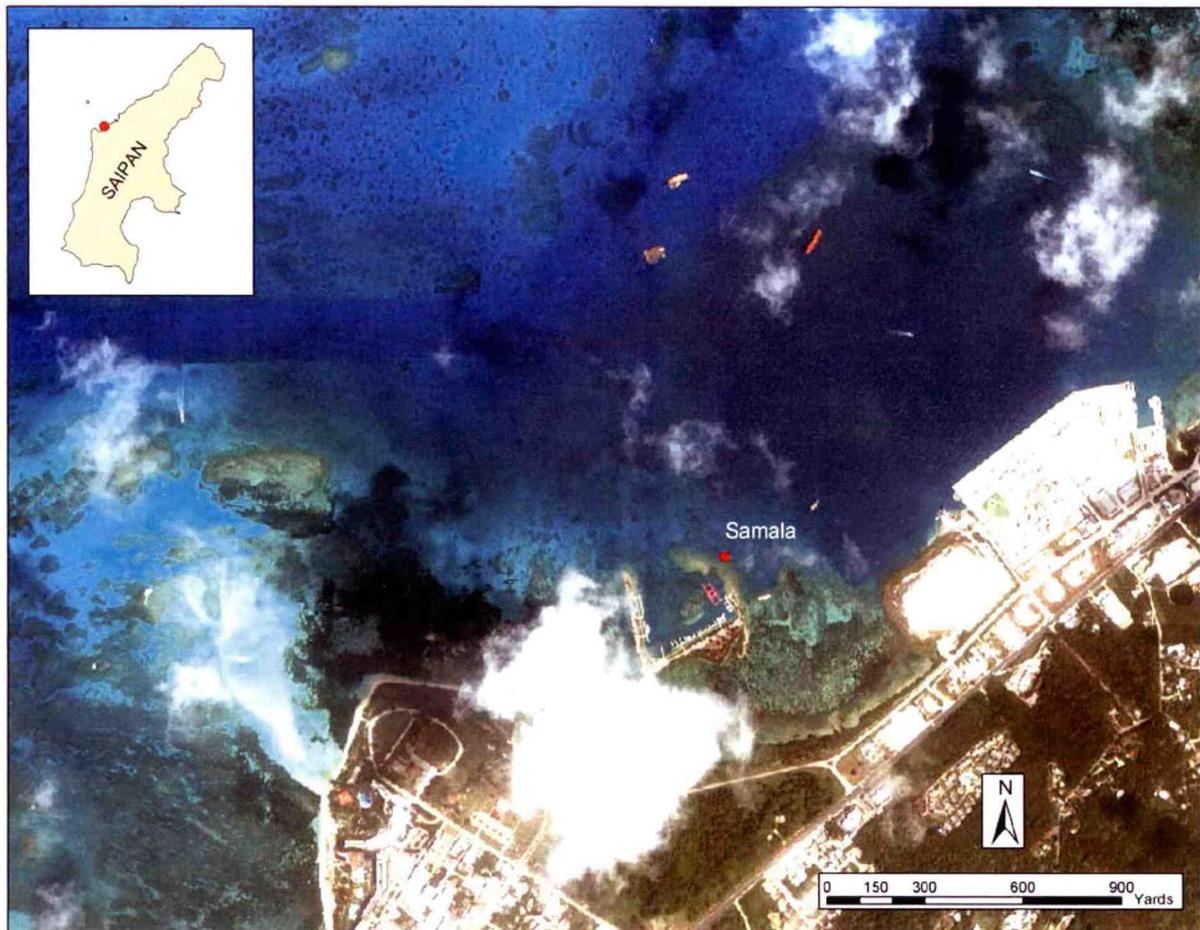
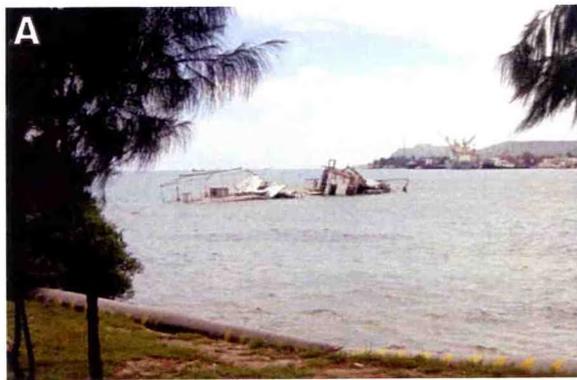
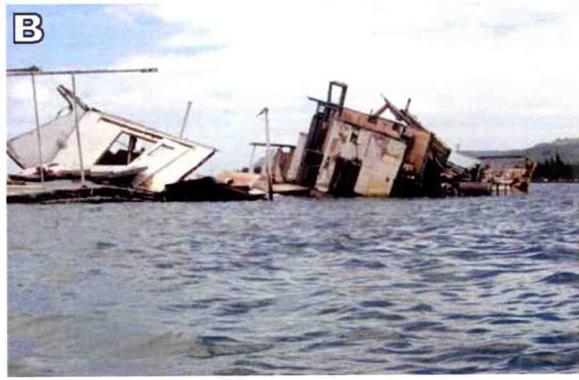
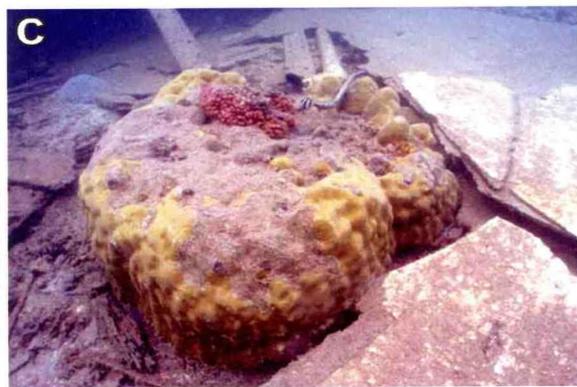
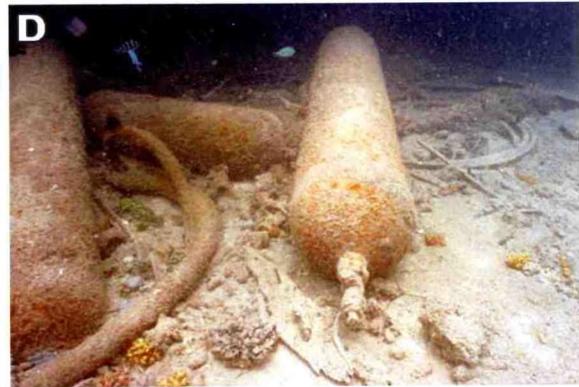
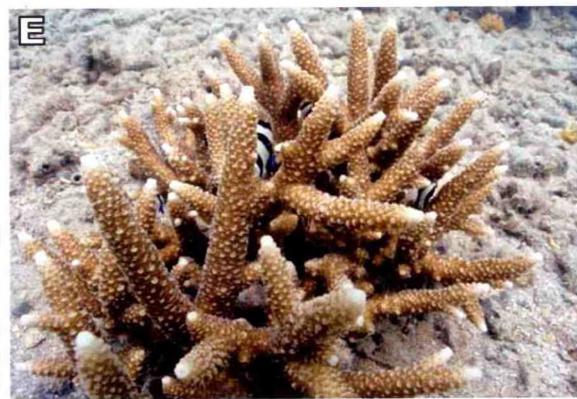
PLATE 2. *Samala*, Outer Cove Marina, Saipan.

Vessel Information: The *Samala* (Incident ID: 1251) is a 110 ft recreational wooden cabin cruiser that has been hard aground, possibly since a 1988 typhoon. The vessel is in poor and rapidly deteriorating condition. The hull has broken into multiple sections and an extensive debris field is beginning to form. Smaller, lighter debris was found washed up in the low energy back bay a long distance from the site. The vessel's fuel tanks are intact and may contain fuel. Vessel ownership is unknown.

Photographs of *Samala* (5 June 03):
 A. View from access point at Outer Cove Marina.
 B. View of wooden cabin deterioration.
 C. View of debris on *Porites* coral head immediately adjacent to vessel.
 D. Compressed gas tanks observed in debris.
 E. View of *Acropora* and damselfish near vessel.

Removal Scenario: High priority for removal.

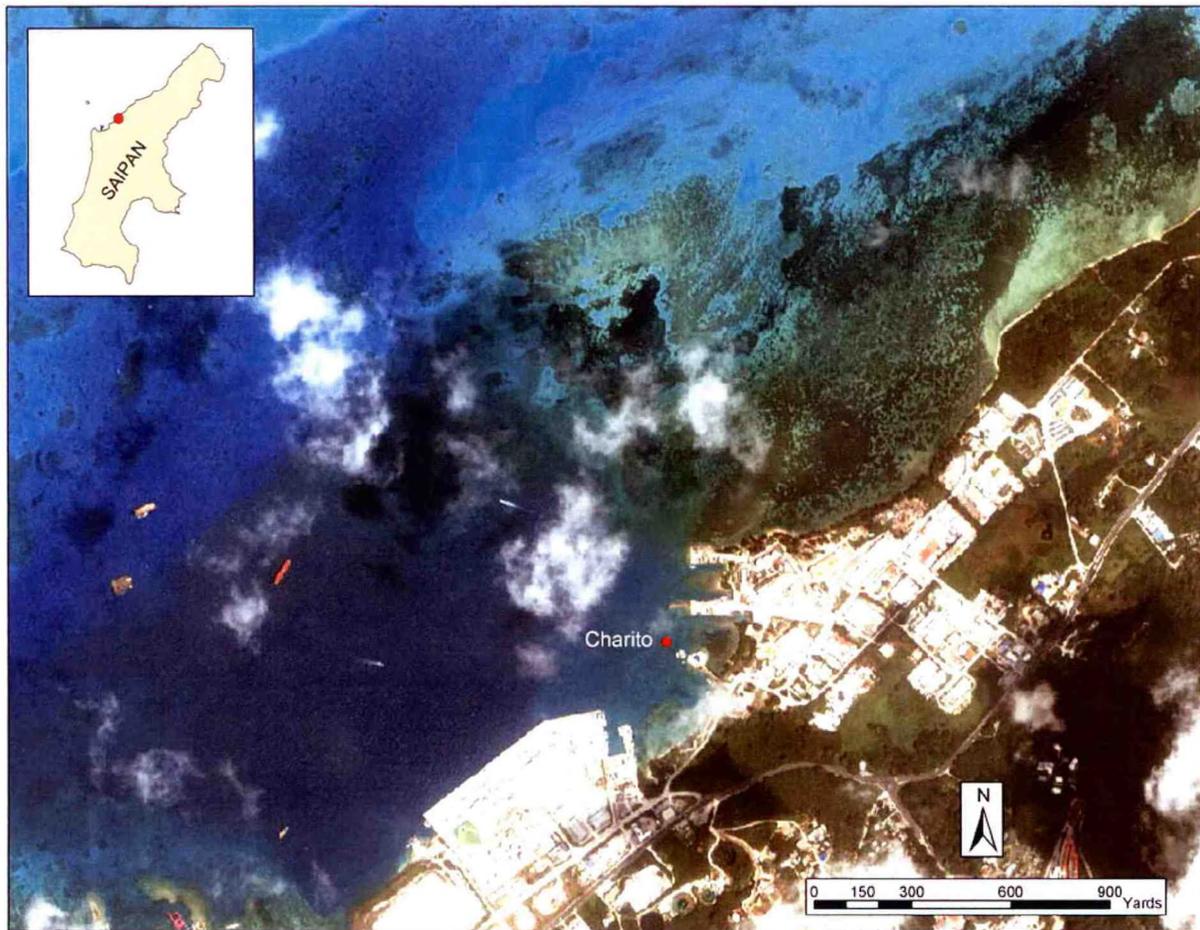
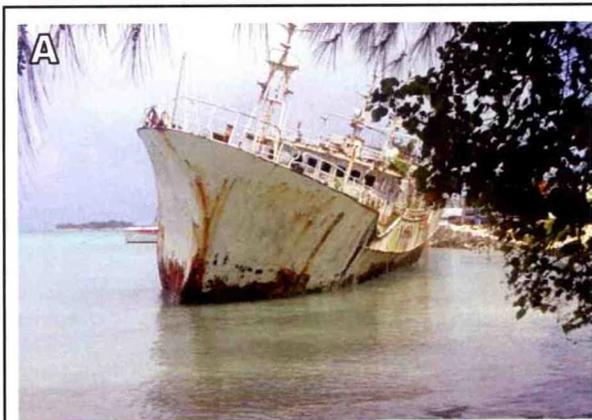
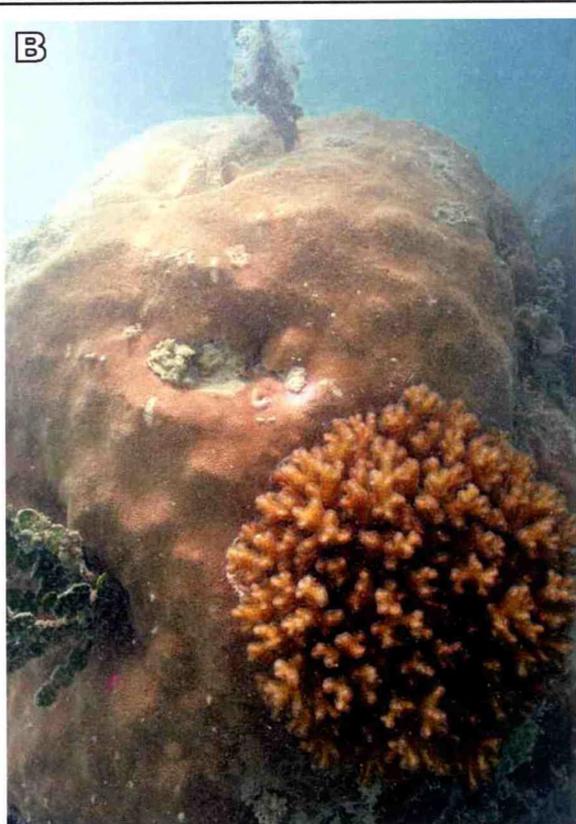
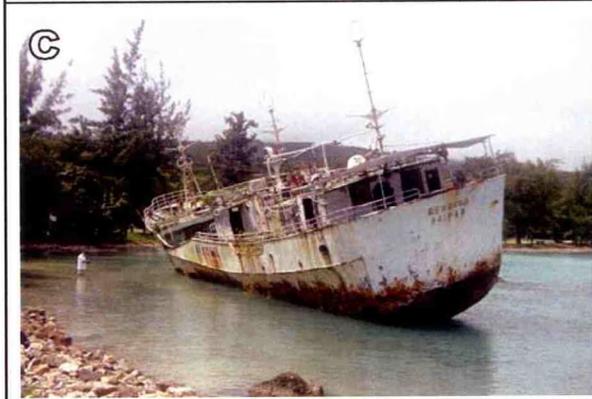
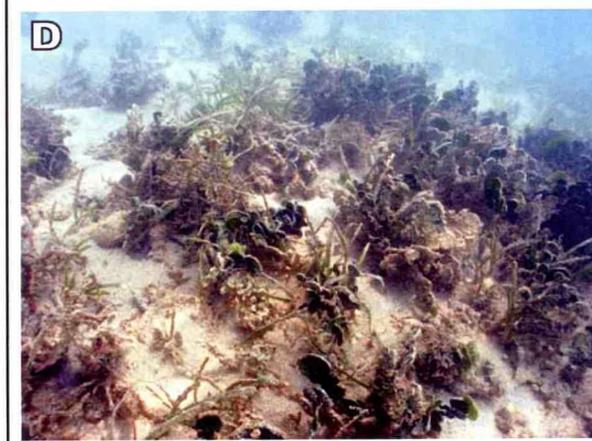
PLATE 3. *Charito*, Lower Base, Saipan.

Comparison to Other Vessels/Removal Considerations: The vessel is located in a high use recreational fishing, boating, and birding area. A small boat launch and anchorage are located 500 ft from the vessel. Local officials view the vessel as an eyesore and potential threat to other boats/facilities if it were to move during a storm. They are very interested in removing it.

Photographs of Charito (5 June 03):
A. View from shore of bow.
B. View of coral (*Porites* and *Acropora*) and macroalgae at site.
C. View of stern and proximity to shore.
D. View of macroalgae (*Halimeda macroloba* and *Caulerpa taxifolia*) and seagrass (*Enhalus macroroides*) near vessel.

Removal Scenario: High priority for removal.

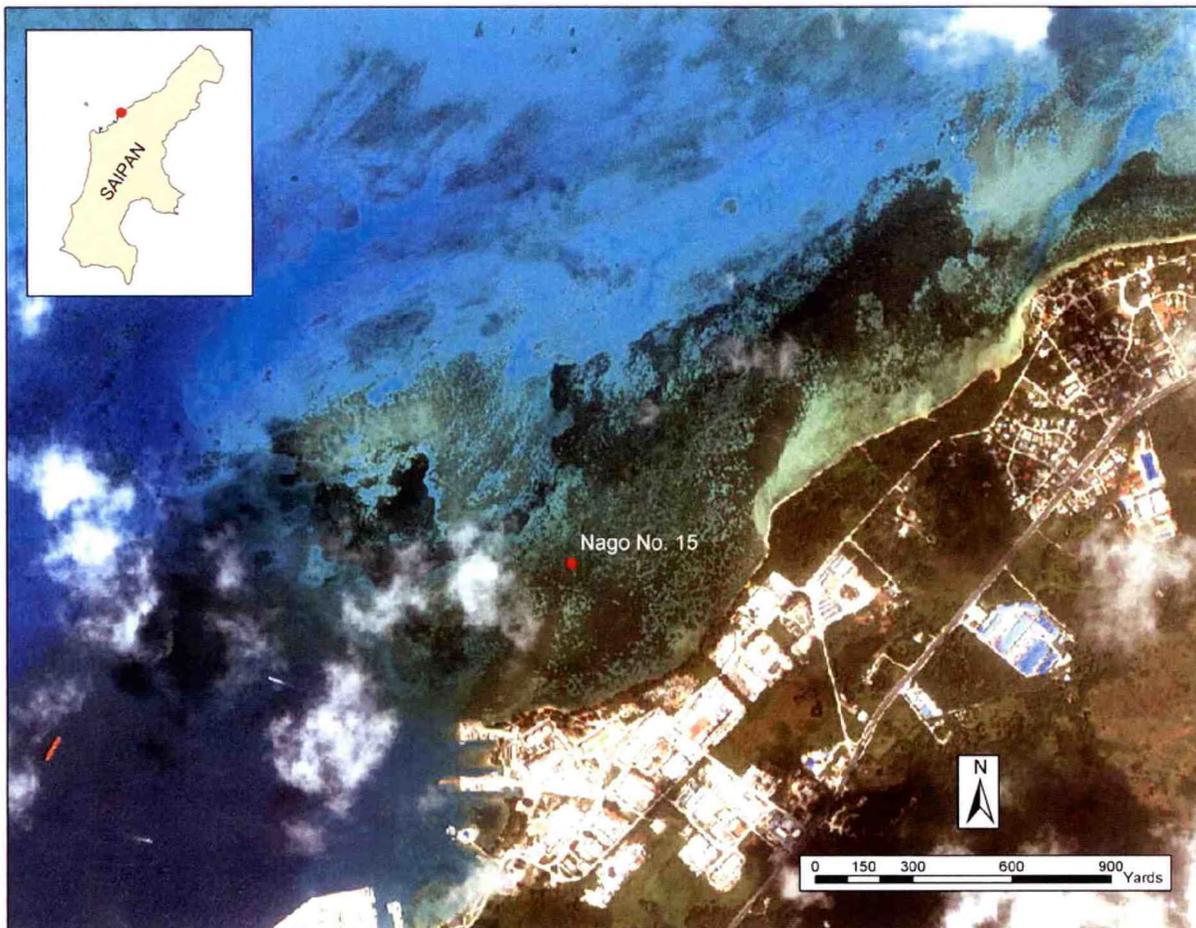
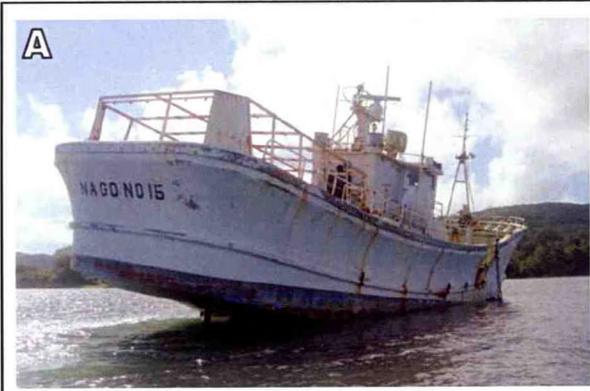
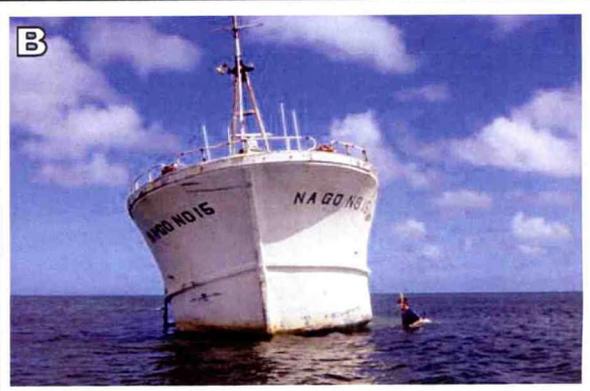
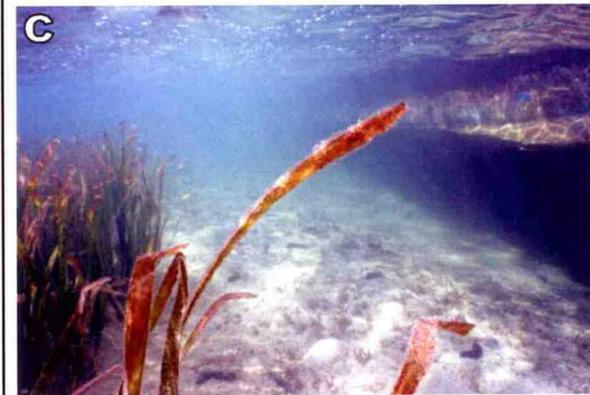
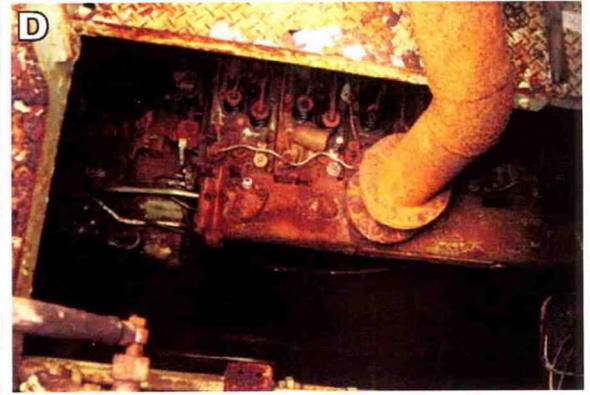
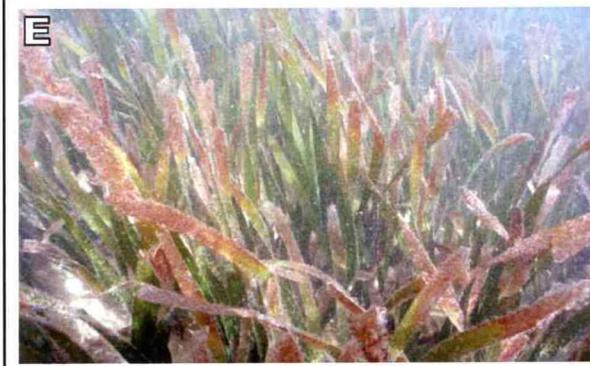
PLATE 4. *Nago No. 15*, Saipan Lagoon, Saipan.

Comparison to Other Vessels/Removal Considerations: Seagrass coverage surrounding the vessel was denser and covered a more extensive area than in all other areas surveyed in Guam and CNMI. Previous attempts to remove the vessel failed, but our survey assessment indicated that removal would probably be feasible if performed by experienced personnel.

Photographs of *Nago No. 15* (6 June 03):
A. View of stern.
B. View of bow.
C. Unvegetated scour area that extends 8-20 ft off of port side and bow.
D. Engine compartment in vessel.
E. Dense seagrass habitat adjacent to the vessel.

Removal Scenario: High priority for removal.

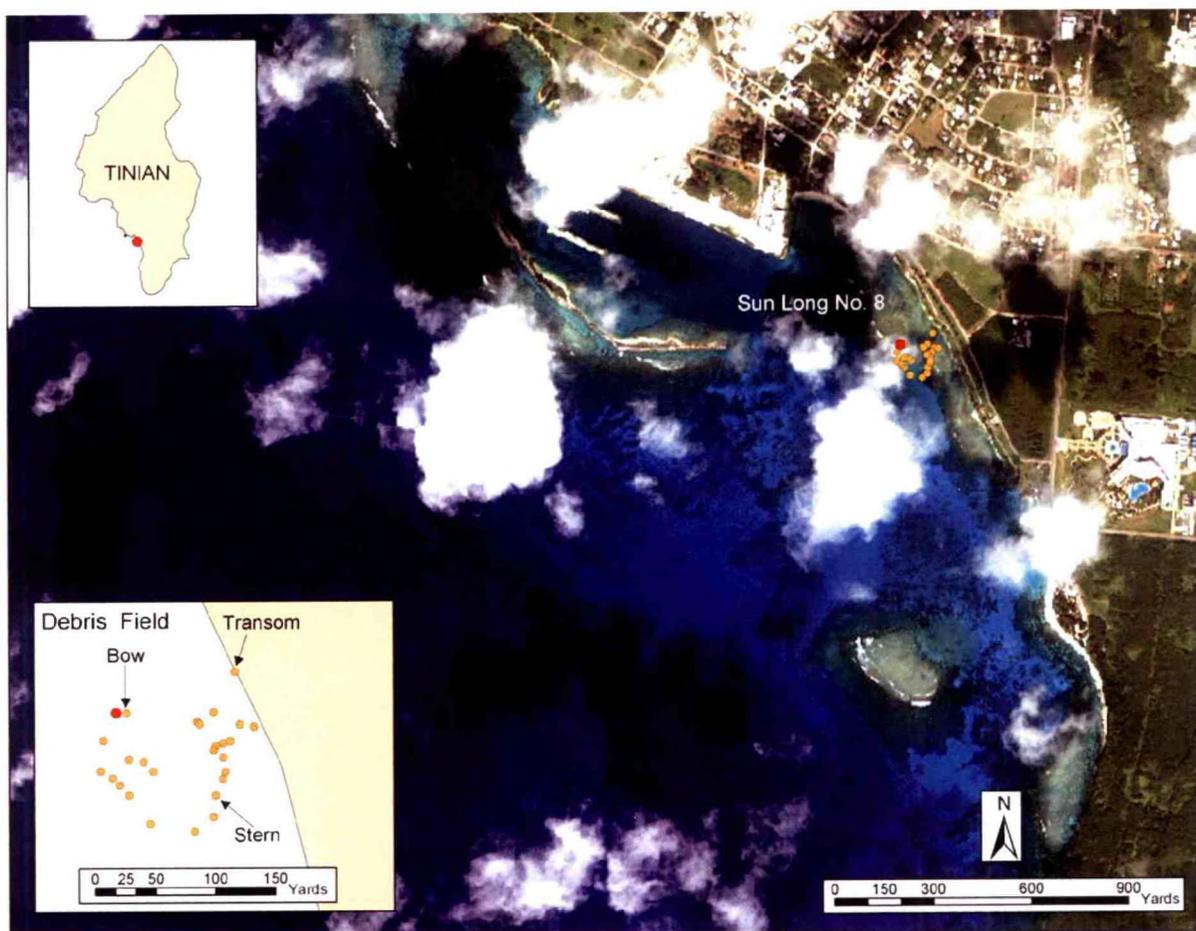
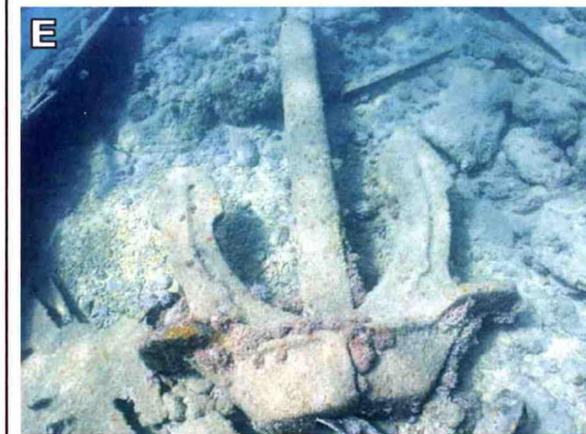
PLATE 5. *Sun Long No. 8*, Tinian Harbor, Tinian.

Comparison to Other Vessels/Removal Considerations: This is one of two sites that had extensive debris fields over a range of depths. *Sun Long No. 8* is one of the largest vessels surveyed at 325 ft.

- A. Kingpost and large piece of debris on shore.
- B. View of large piece of debris on riprap shoreline.
- C. View of dense debris.
- D. Small portion of debris field and sand and gravel substrate with coral rubble.
- E. Anchor among the debris atop sand and gravel.

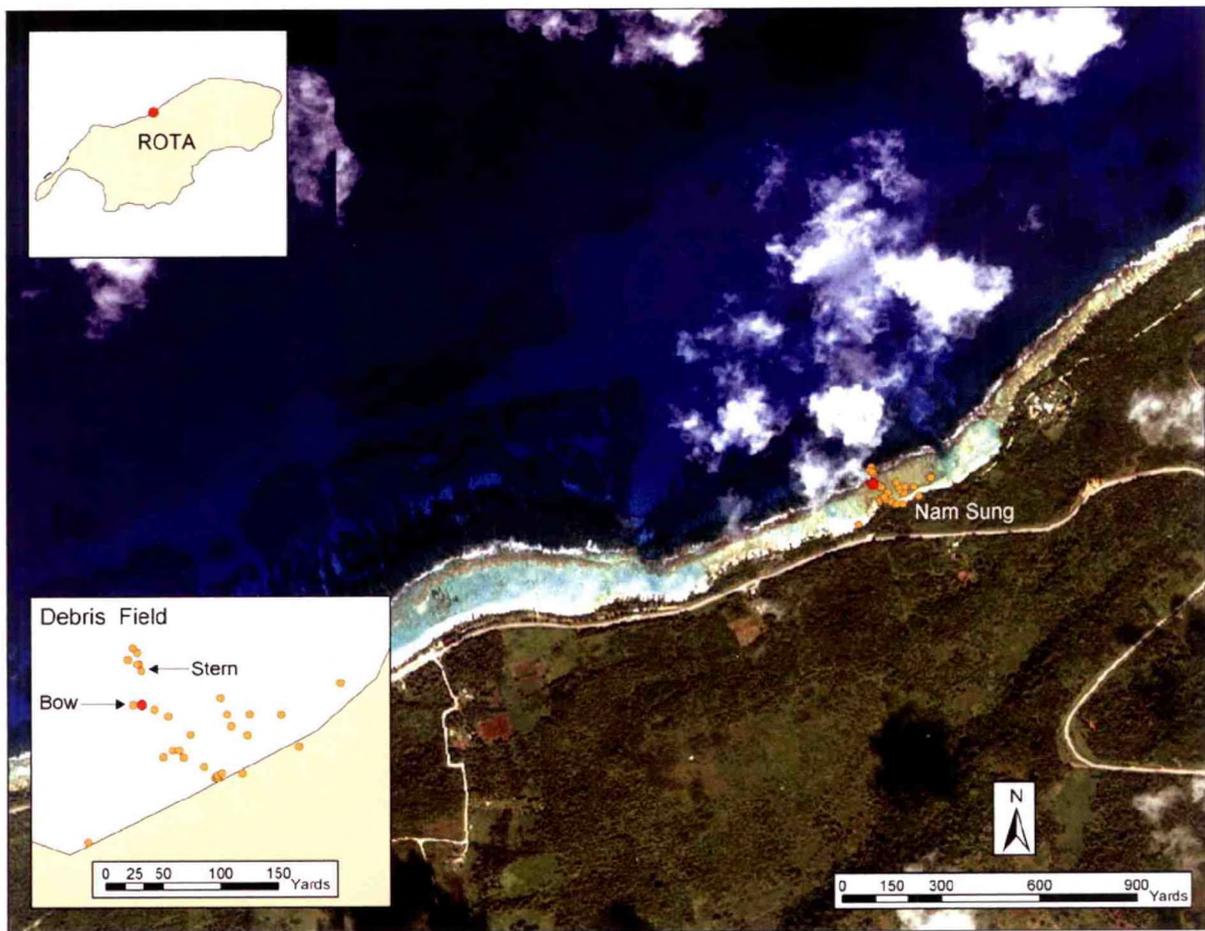
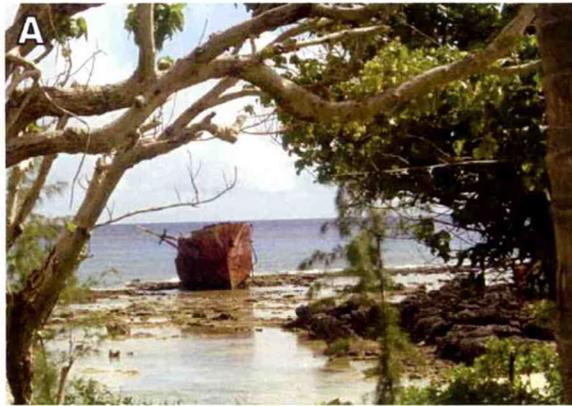
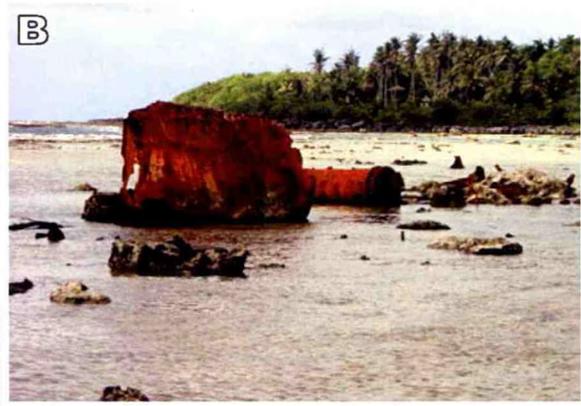
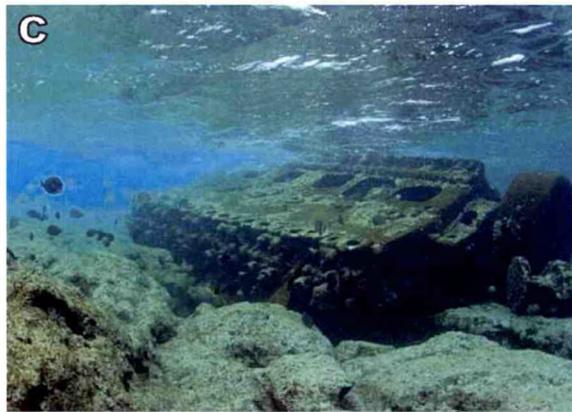
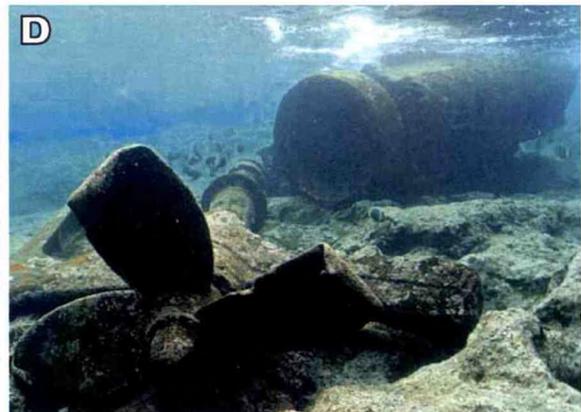
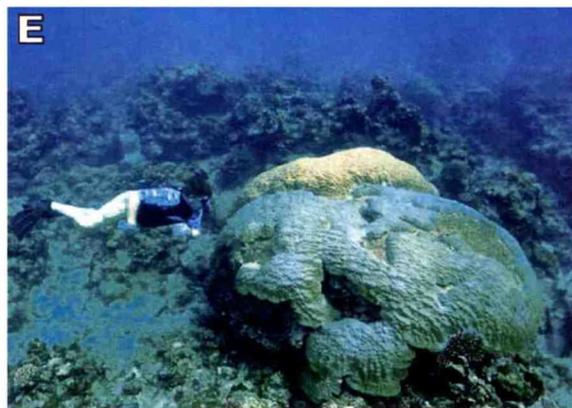
PLATE 6. #62 *Nam Sung*, Sasanlago-Tatqua beach, Rota.

Comparison to Other Vessels/Removal Considerations: One of two sites that had extensive debris fields, this site has debris spread over the greatest area. Heavy surf in shallow area may impede removal. This area had the highest coral species diversity of all areas surveyed in the Pacific region.

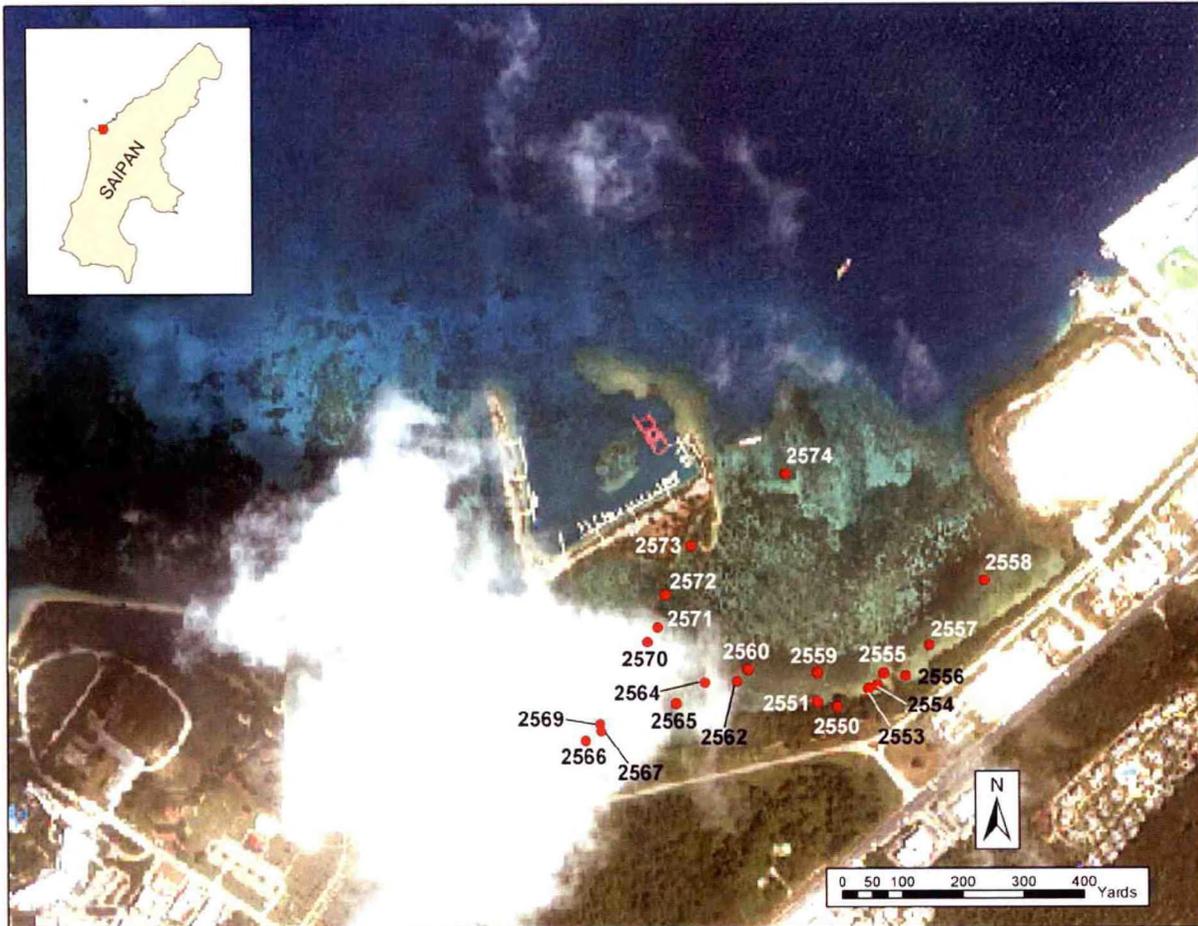
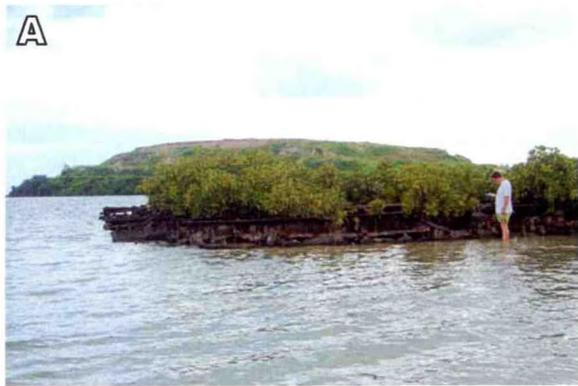
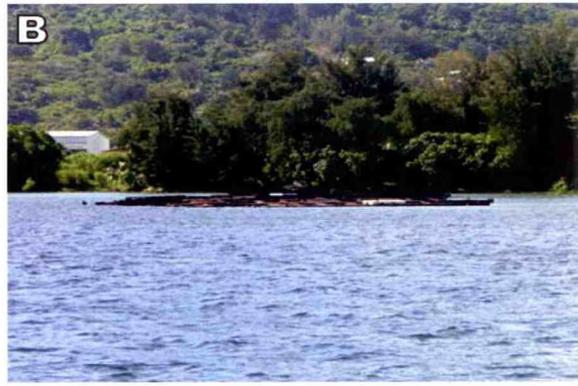
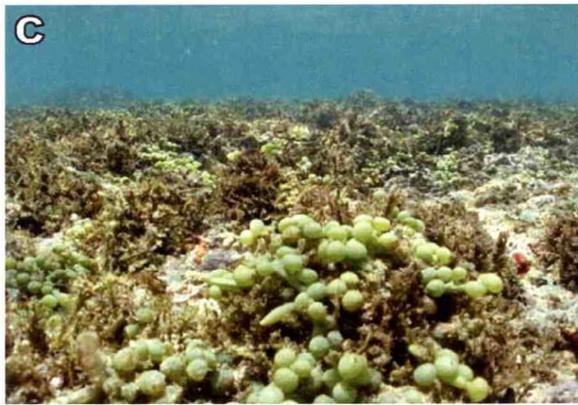
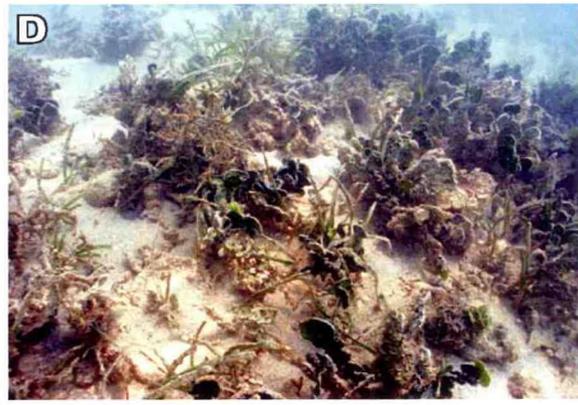
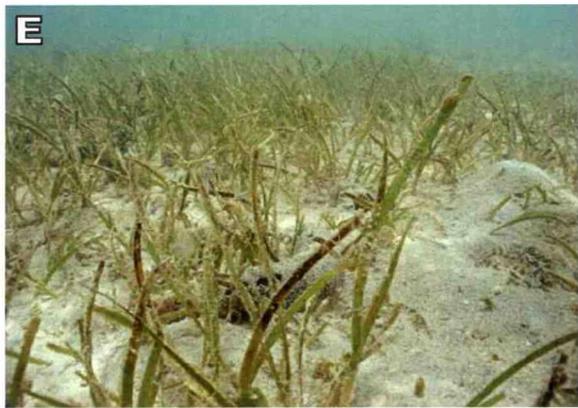
PLATE 7. Barges, Outer Cove Marina, Saipan.

Comparison to Other Vessels/Removal Considerations: Of the historical vessels surveyed, these are the most widespread type, but also appear to be the most deeply entrenched. While they may have historical value, there are large numbers of these vessels present that are rusted and of a nondescript nature.

- A. View of a typical barge; note mangroves growing in vessel.
- B. A typical barge; note very low relief with respect to the water line.
- C. Macroalgae and sandy bottom typical of the barge survey sites.
- D. Macroalgae and sparse seagrass typical of the barge survey sites.
- E. Seagrass and sandy bottom habitat near Saipan barges.

Removal Scenario: Historical considerations.

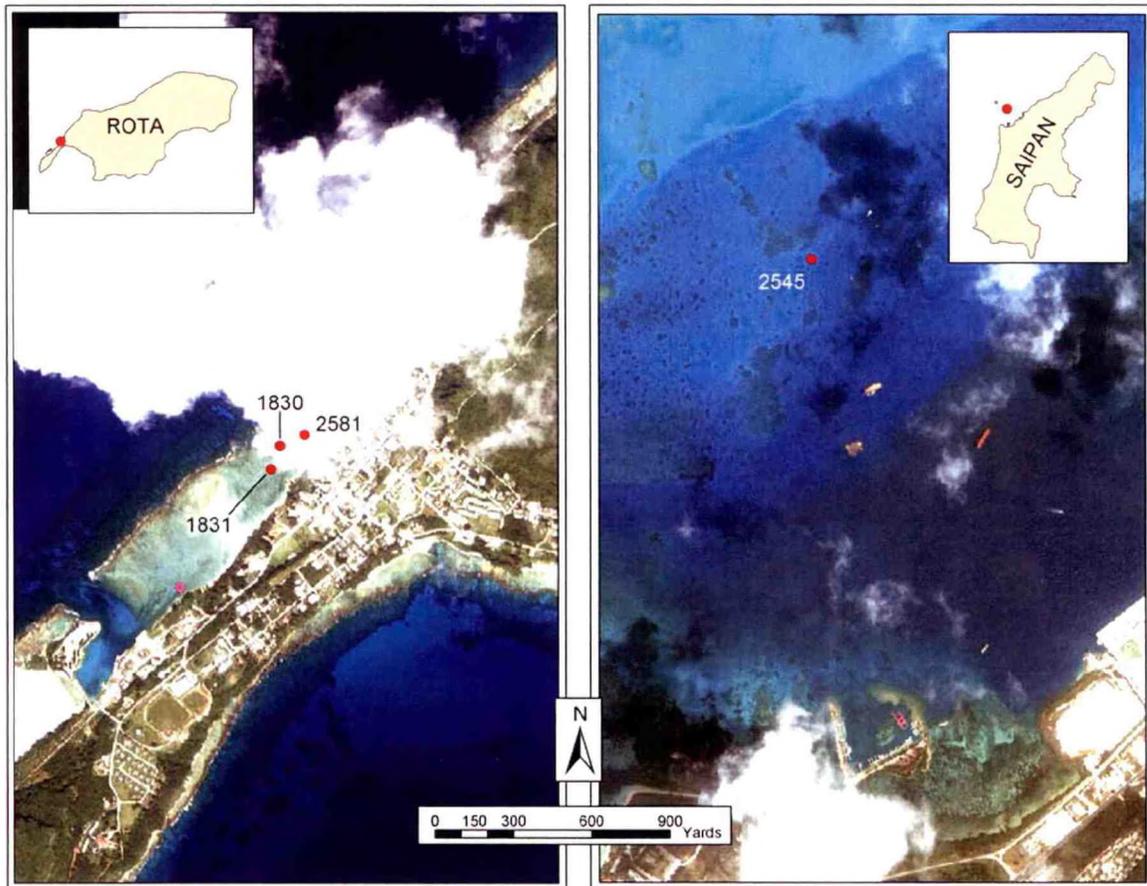
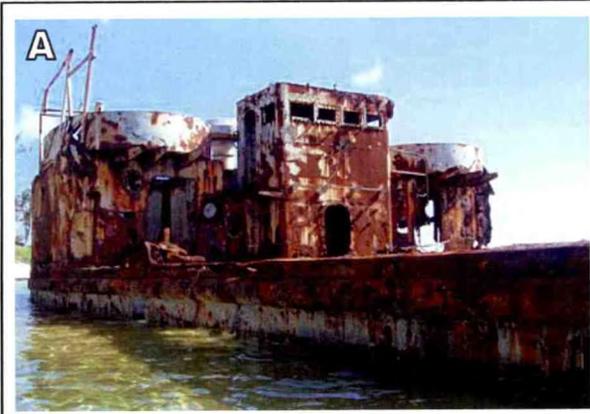
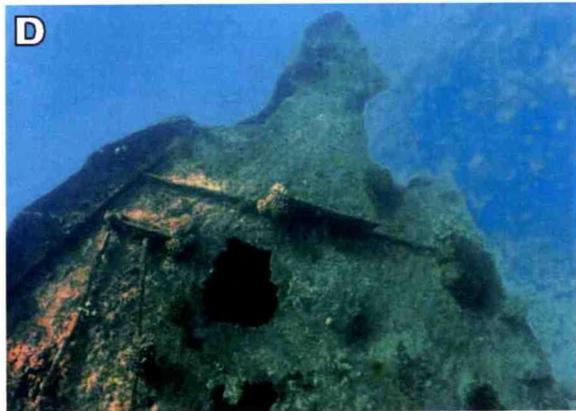
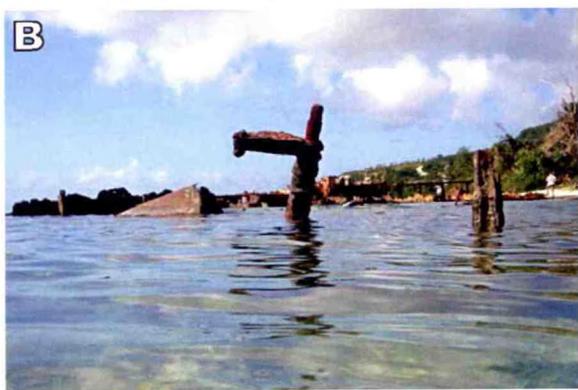
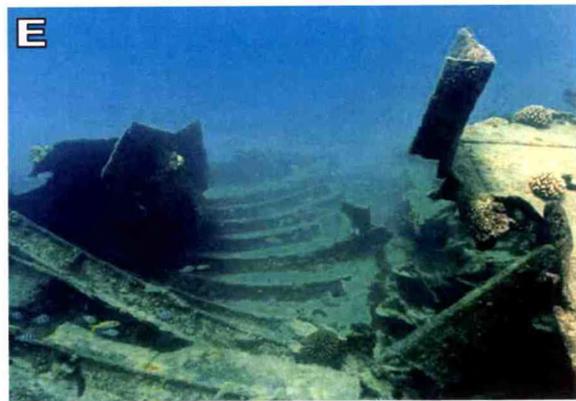
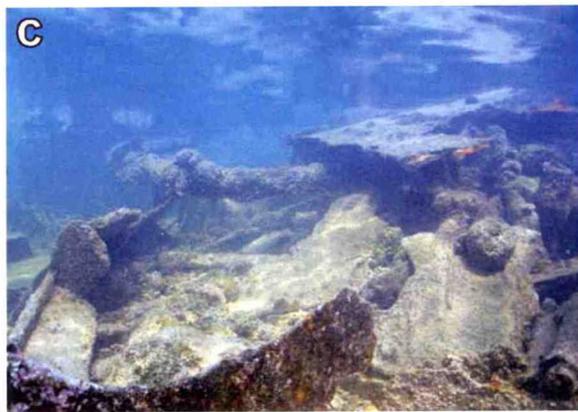
PLATE 8. Additional historic vessels in the CNMI – Three "M-boats" and a Japanese freighter.

Comparison to Other Vessels/Removal Considerations: The M-Boats and Japanese vessel are much larger than the majority of WWII barges surveyed (See Plate 7). There is relatively little debris associated with the M-Boats, which are deeply entrenched like many of the WWII era barges that were surveyed. Unk2545 has deteriorated to an extensive debris field with a few pieces that closely approach the surface.

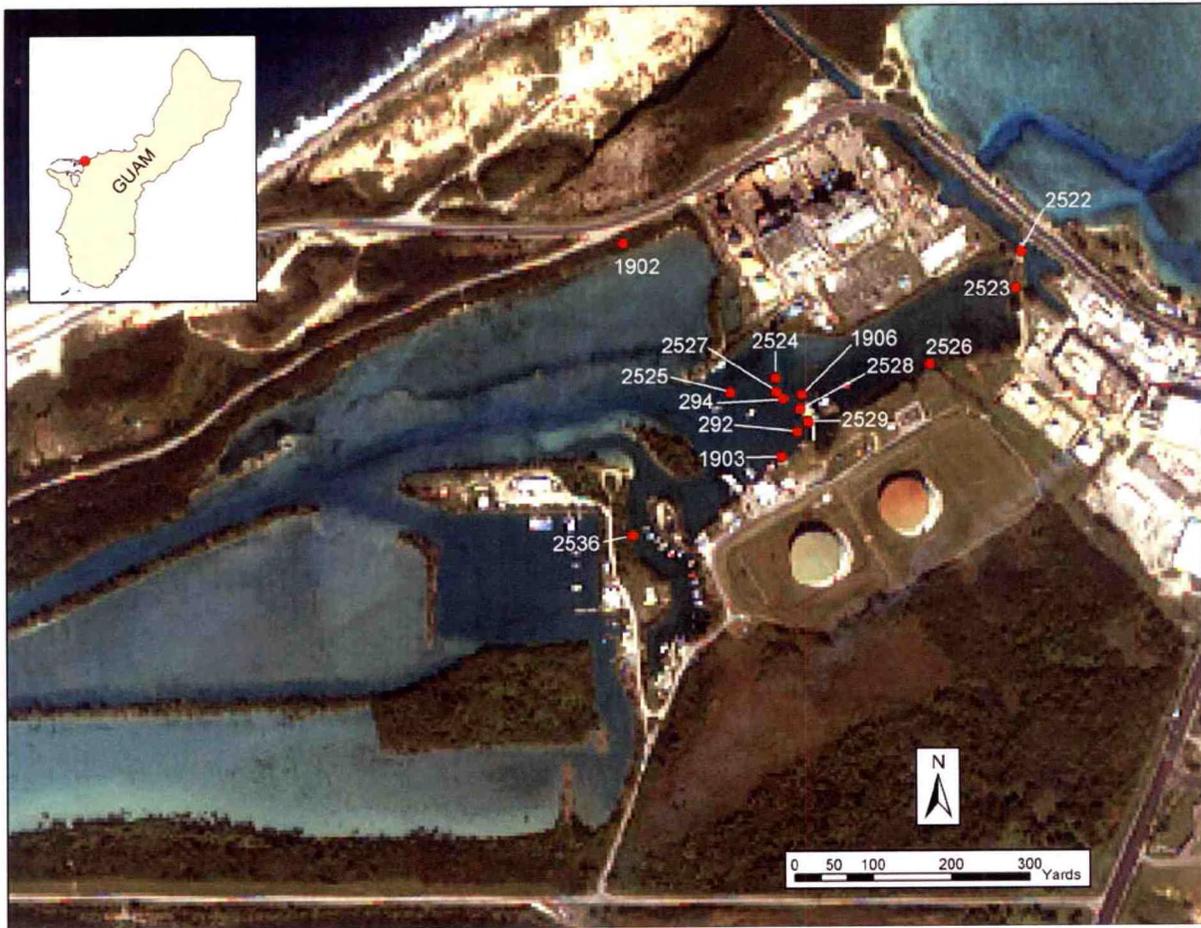
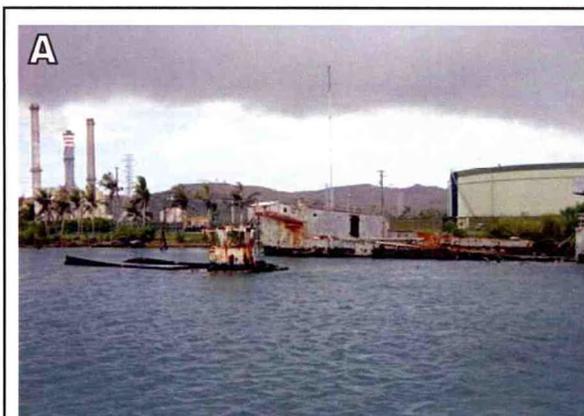
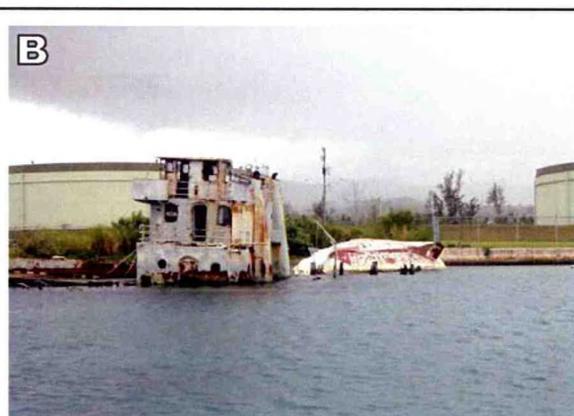
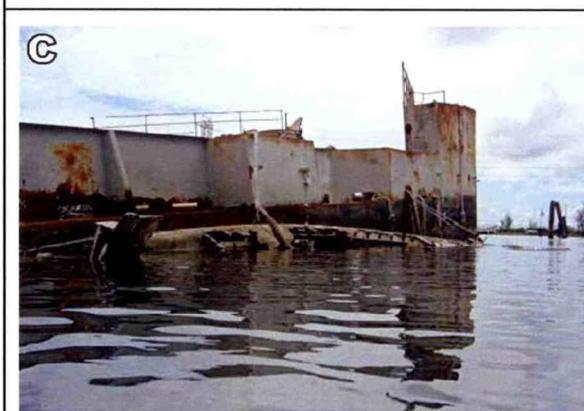
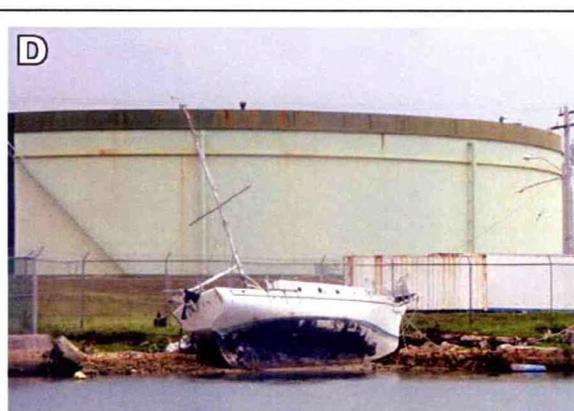
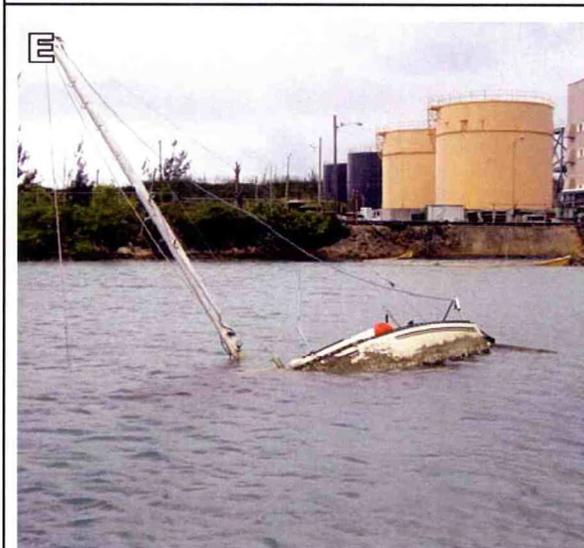
PLATE 9. Piti Channel, Guam.

Comparison to Other Vessels/Removal Considerations: These vessels are in one of the tighter “clusters” found in the survey. These types of areas often become dumps for abandoned vessels, and several similar areas were surveyed in the U.S. Caribbean. None of these vessels are a pollution threat but all are threats to navigation.

- A. View to the SE from within the Piti Channel towards Unk1906 (foreground) and *Gauhan-2* (back).
- B. Photo taken just west of image A, showing *Chamorro-1* (right) and its proximity to *Gauhan-2* (left).
- C. Unk2527 (foreground) lying against the starboard side of *Gauhan-2*.
- D. *Merlin* aground just southwest of *Chamorro-1*; note the seawall and storage tank in both image B and D.
- E. *Dolphin Dancer*, photo taken just north of other vessels.
